# Abandoned Uranium Mine Site Assessment for the Dysart No. 1 Site (NM0041)

## FINAL REPORT

NM0041

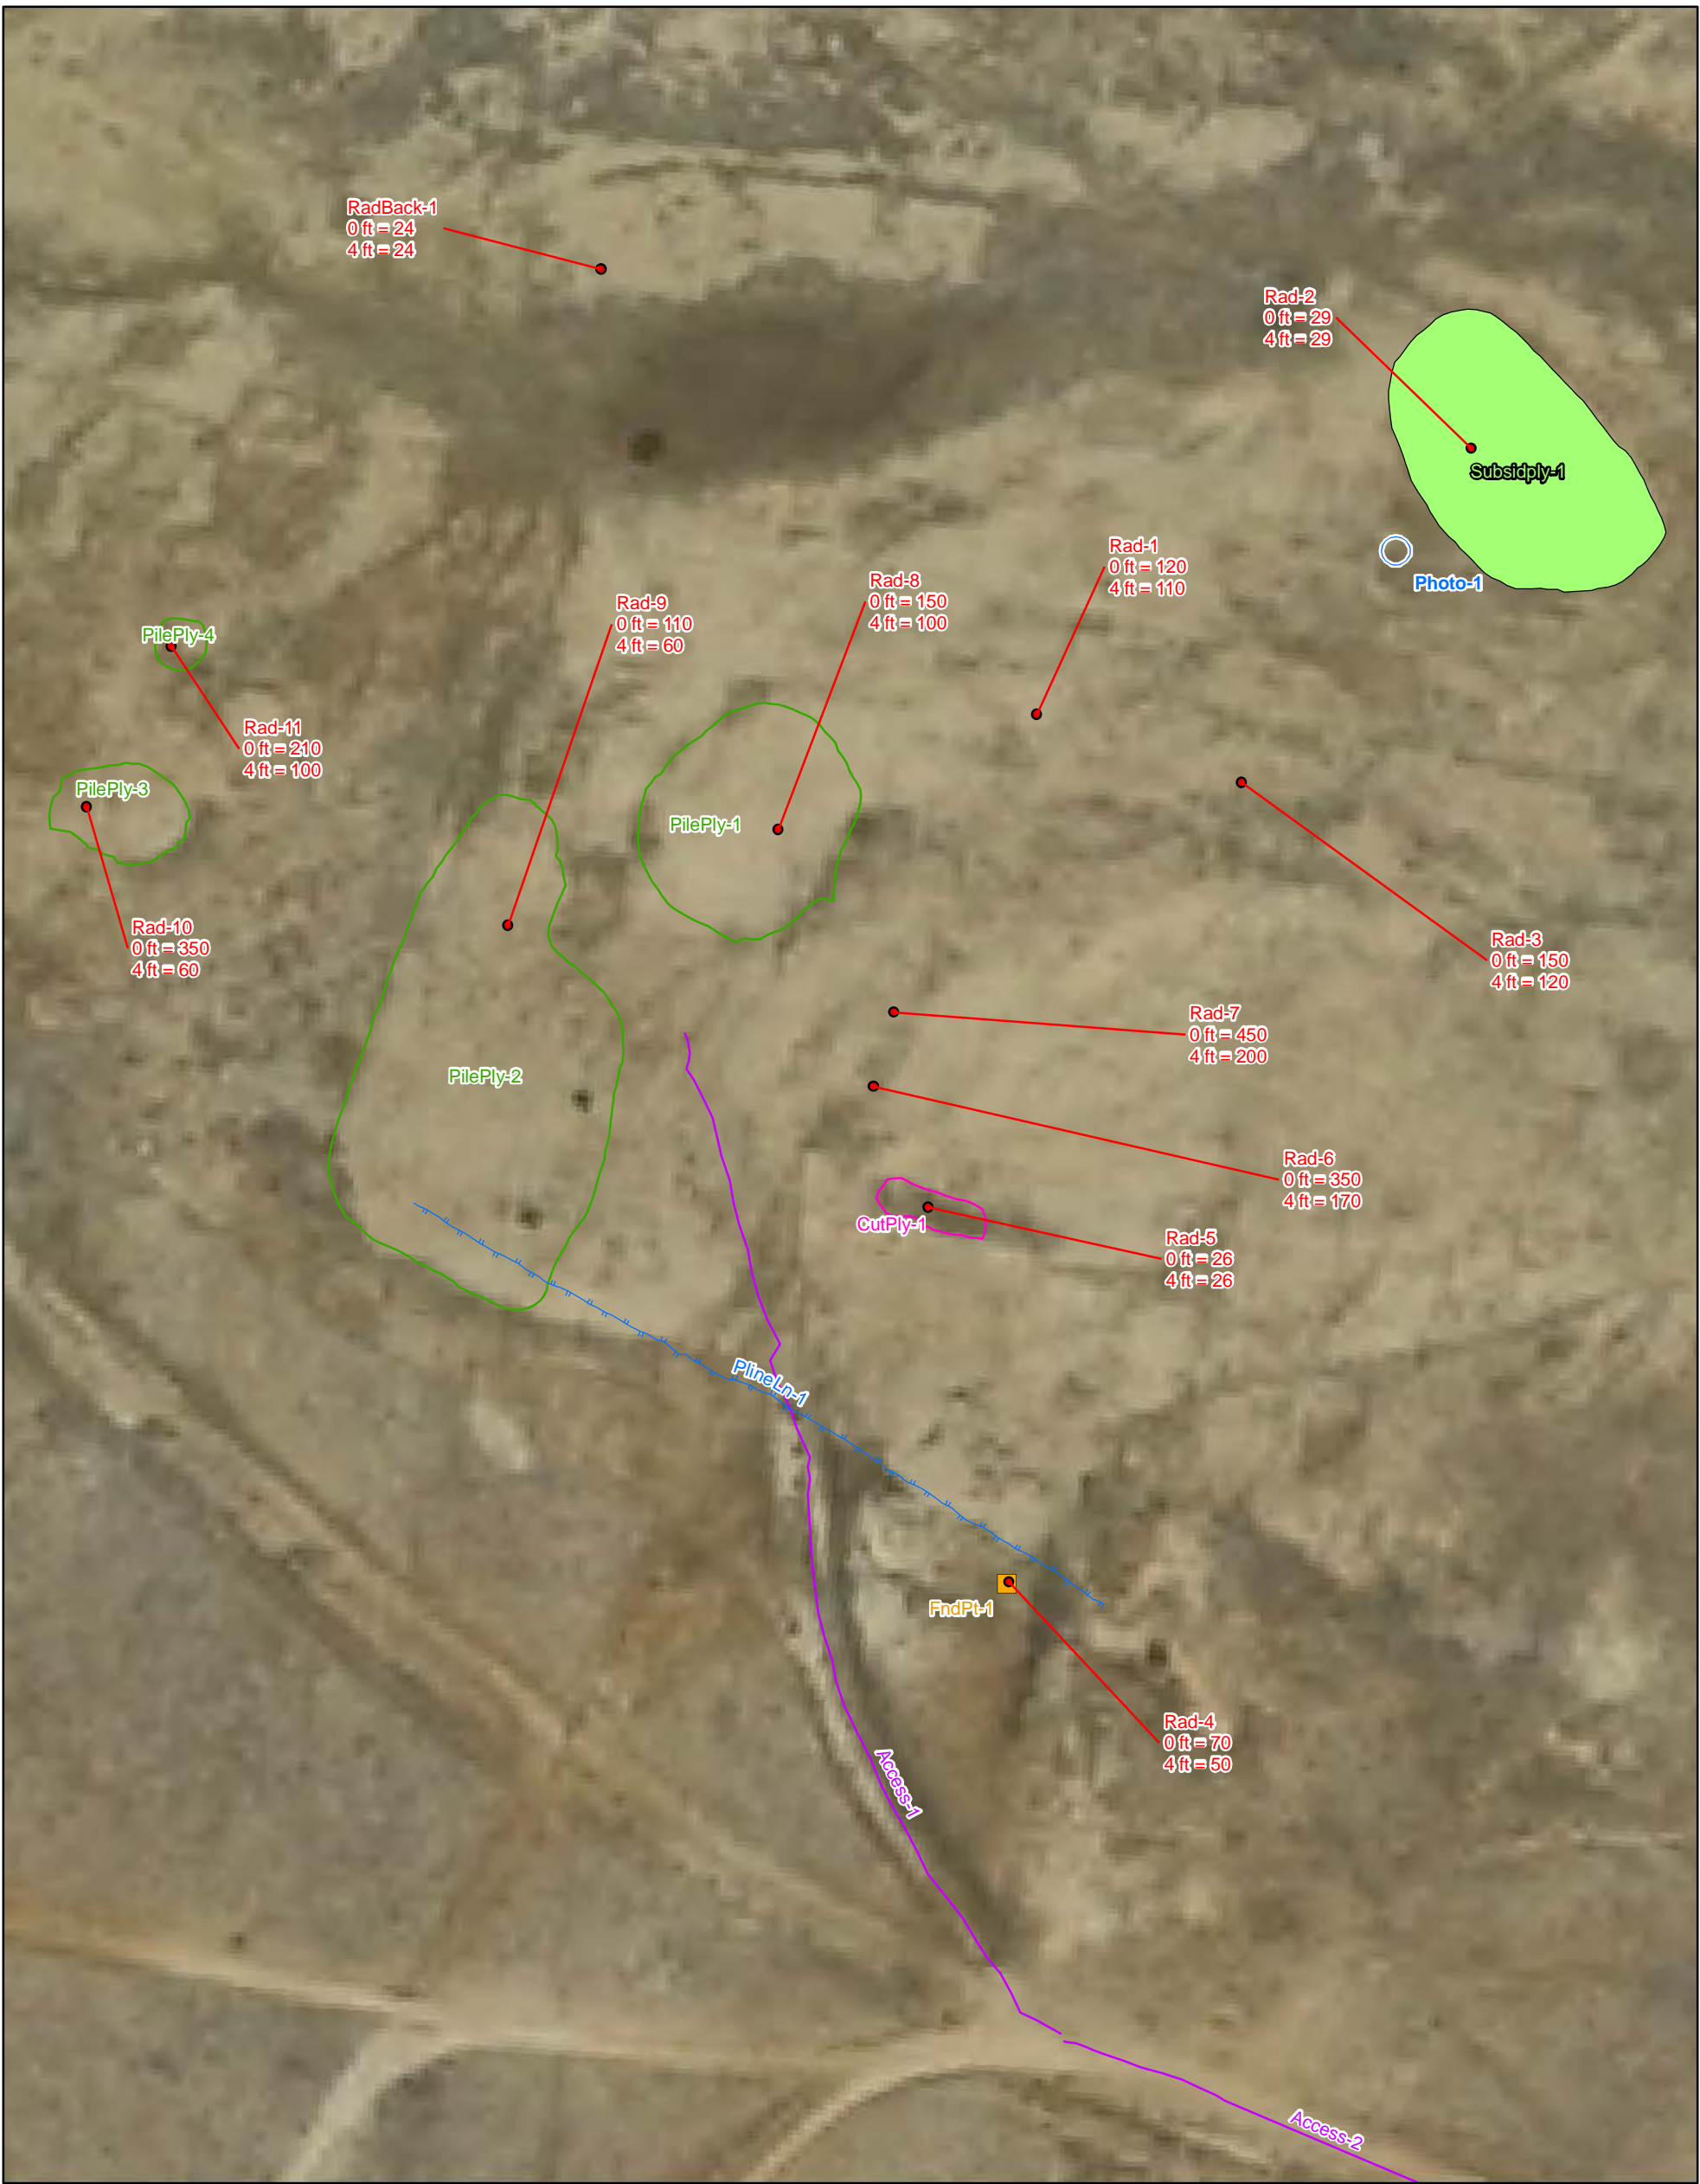
**Figure 4a**  
**Site Map on**  
**Aerial Photo**  
**NM0041-Dysart No. 1**  
Abandoned Uranium  
Mine Assessment

The mine features described below are based on the features provided to INTERA by MMD in the GIS Data Dictionary (MMD, 2009). INTERA marked the locations of the AUM Site features using a Trimble Global Positioning System (GPS), and entered details about the features into the GPS using the MMD data dictionary. One open cut, one foundation, four piles, a subsidence feature, and power lines were found onsite. Please see the Photo Log in Appendix A for photos of the AUM Site features, Table 1 for a list of the AUM Site features, and Figures 4a and 4b for the locations of the AUM Site features.

radiation readings taken at the AUM Site and Figures 4a and 4b for the locations of the radiation readings.

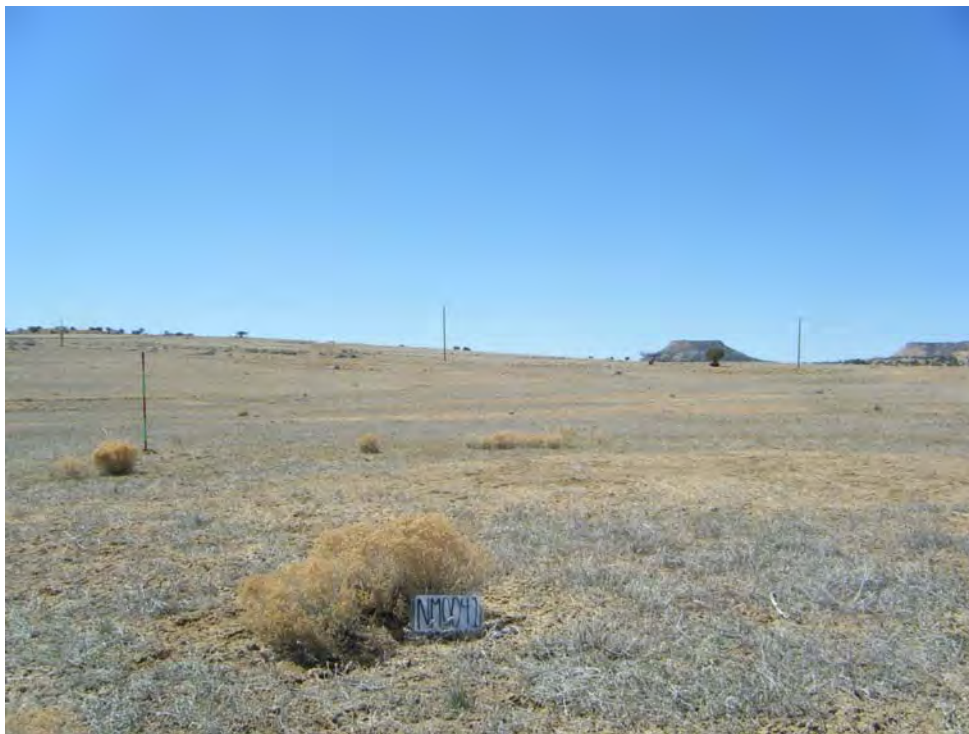
Photo 1-Site photo, looking southwest.

Site Name: NM0091, Dyserf No. 1Objective: Site AssessmentPersonnel: Annelia Tinklenberg  
Danny BowmanEquipment: Rental truck, Trimbel GeoXM  
(SN: 9948447271, 2008 series), Ludlum 192  
(SN: 234149), Fujifilm digital camera  
(No. 80839493), backup Garmin GPS, cell phone  
amplifier, field laptop1200 <sup>ALT</sup> ~~ACT~~ At AUM SiteBackground Rad - Om - 24  $\mu$ R/h; 1m - 24  $\mu$ R/hRad-1 - center of shape-file polygon; Om - 120  $\mu$ R/h;  
1m - 110  $\mu$ R/h<sup>RAD</sup> Photo 1 - Site Name looking southwest

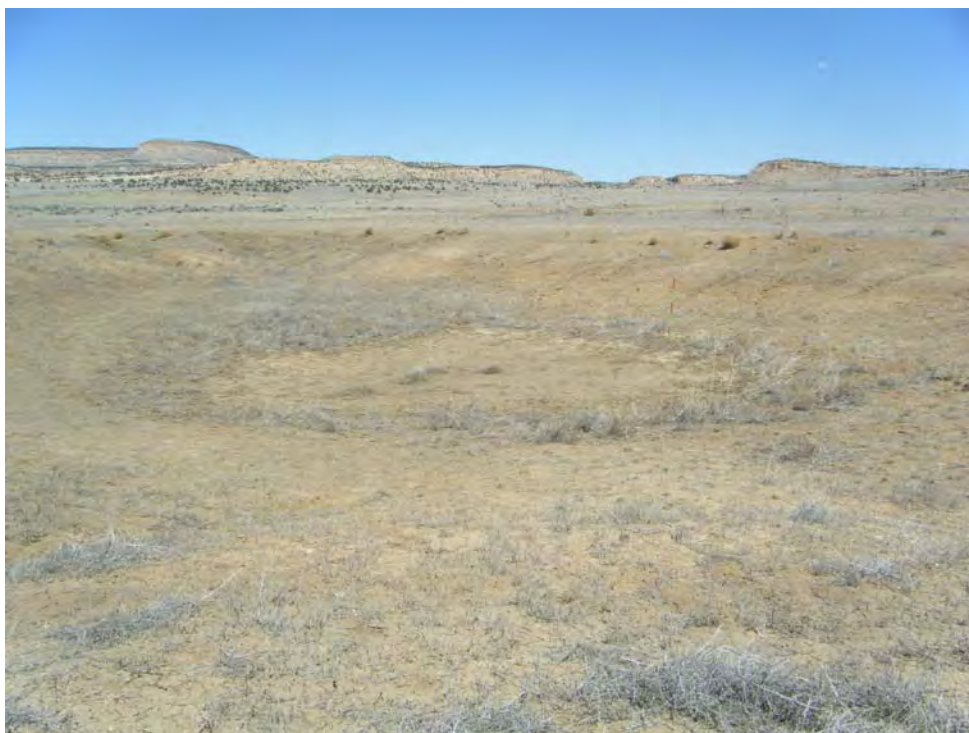
A possible subsidence feature (SubsidPly-1) was observed on the northeast corner of the AUM Site (see Photos 2 and 3 in Appendix A). This feature is 180 ft long, 90 ft wide and 10 ft deep. A power line (Pline-1) crosses the southern portion of the Site (see Photo 6 in Appendix A). This power line trends northwest-southeast and may be the same as the power line in Photo (a) in Anderson (1980).

Photo 2-Looking north at possible subsidence feature (SubsidPly-1).

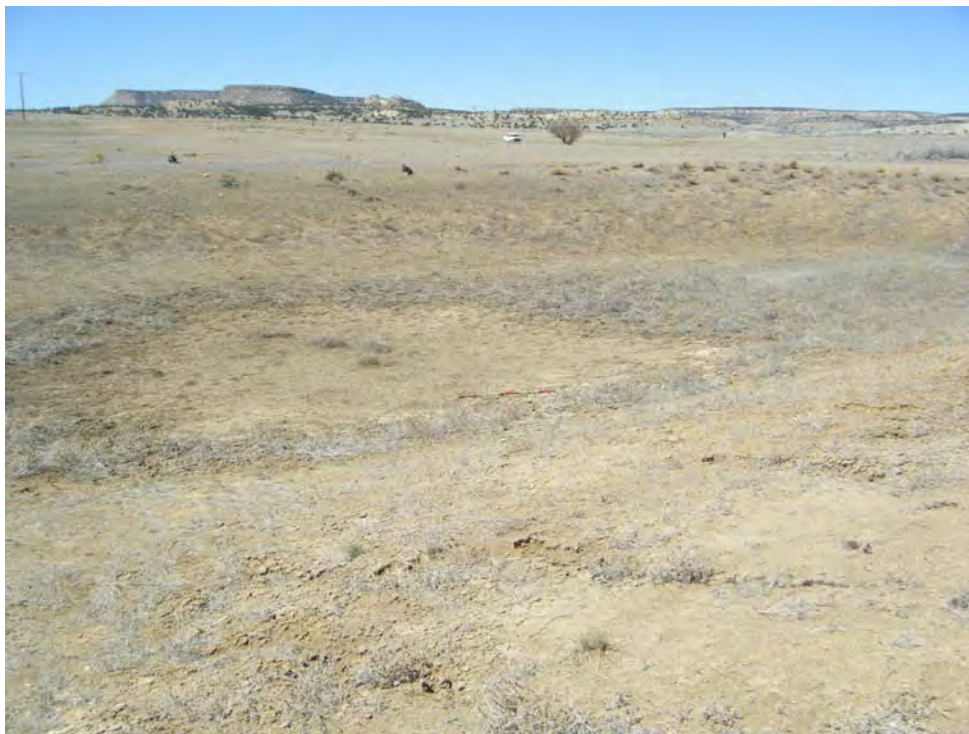
Photo 3-Looking west at possible subsidence feature (SubsidPly-1).

Subsid Ply-1 - 10' deep, 90' wide, 180' long; water collects

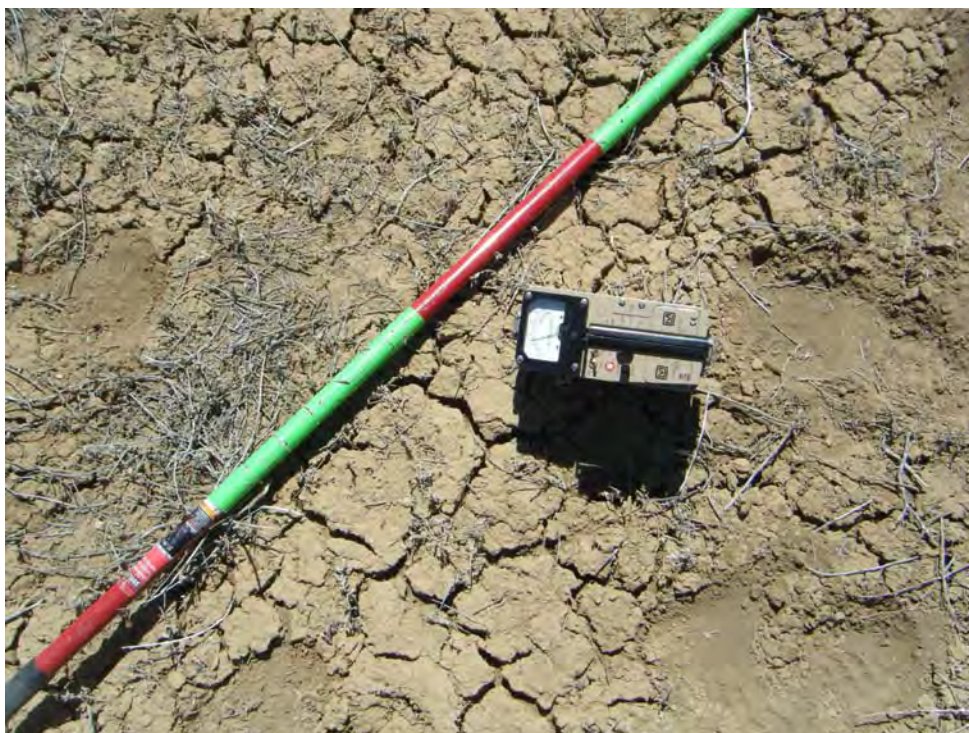
The maximum gamma radiation reading for the AUM Site was 450  $\mu\text{R/hr}$  at 0 ft above ground at radiation survey point Rad-7. Radiation survey points Rad-1, Rad-3, Rad-6, and Rad-7 detected gamma radiation above 100  $\mu\text{R/hr}$  at 0 ft above ground, but these readings were not associated with obvious mine features (see Photo 8 in Appendix A). Gamma radiation survey points on each of the four waste piles also read above 100  $\mu\text{R/hr}$ .

Photo 4-Radiation survey point Rad-3 (150  $\mu$ R/hr at 0 meters).

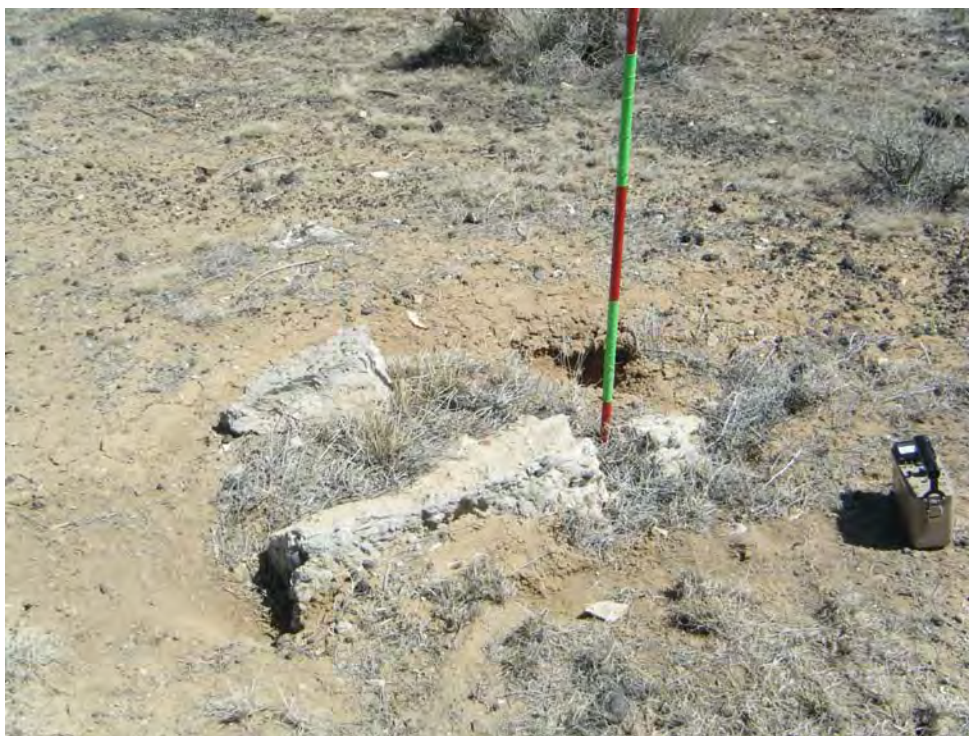
One foundation (FndPt-1) was found at the AUM Site. This foundation consisted of broken cement blocks (see Photo 5) and may correspond to the caretaker's house in Photo (a) in Anderson (1980).

Photo 5-Looking northeast at remnants of a foundation (FndPly-1).

End Pt-1 - cement blocks from a foundation, 3' x 3'

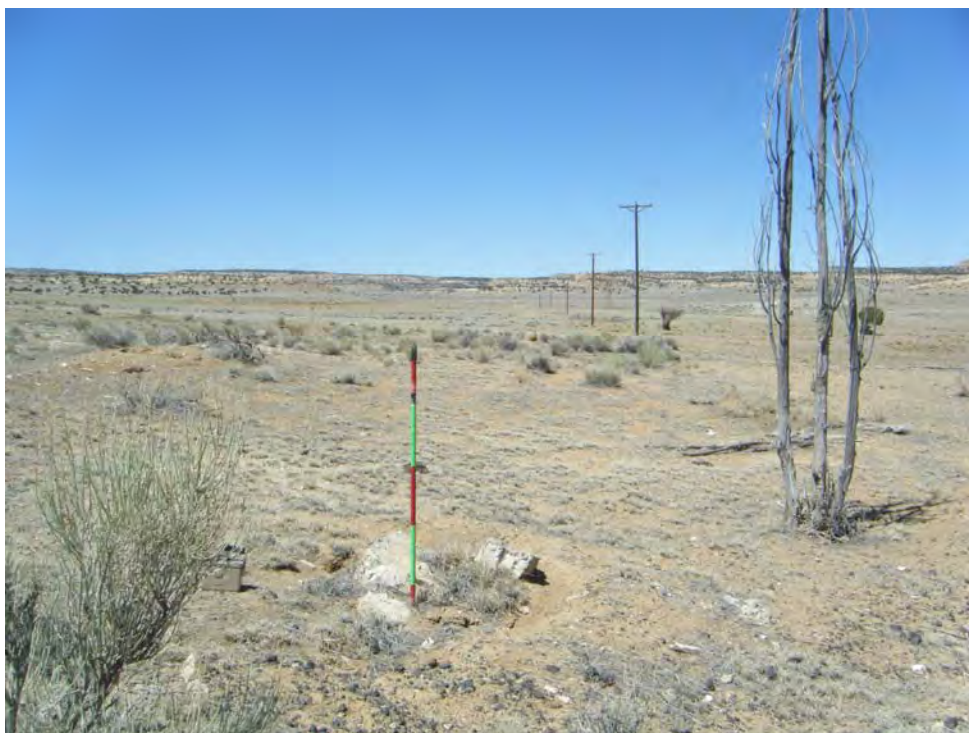
Photo 6-Looking west at power lines running through Site (PlineLn-1).

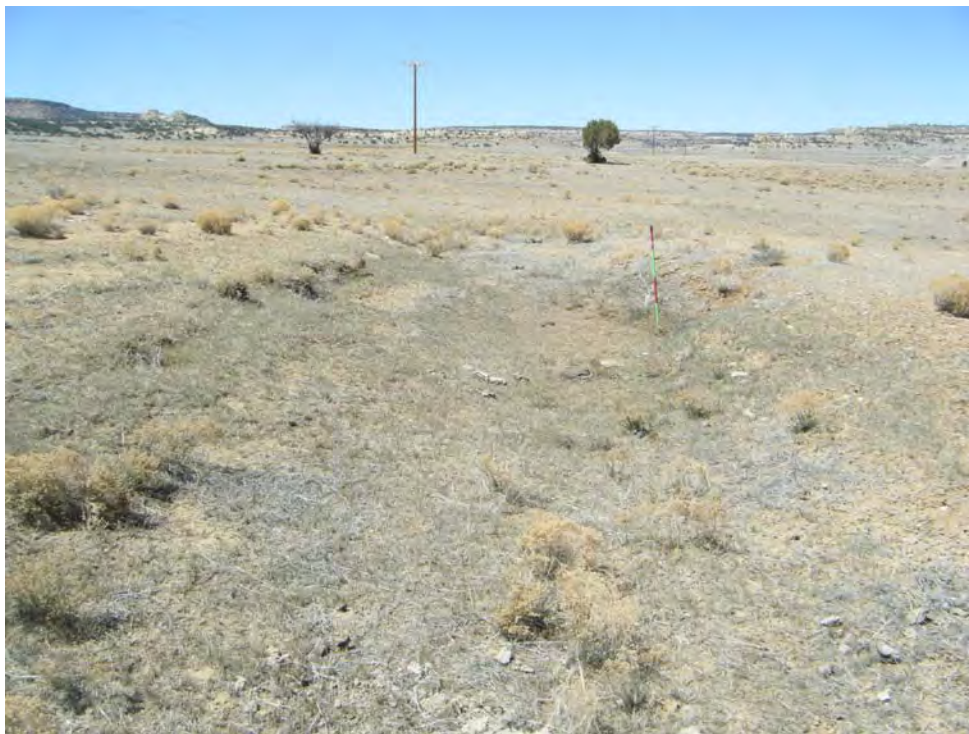
One open cut (CutPly-1) was found at the AUM Site (see Photo 7 in Appendix A). This feature is a small, linear cut with gamma radiation levels equivalent to background.

Photo 7-Looking west at CutPly-1.

Cut Ply-1 - 3' deep, 15' wide, 60' long; bulldozed cut

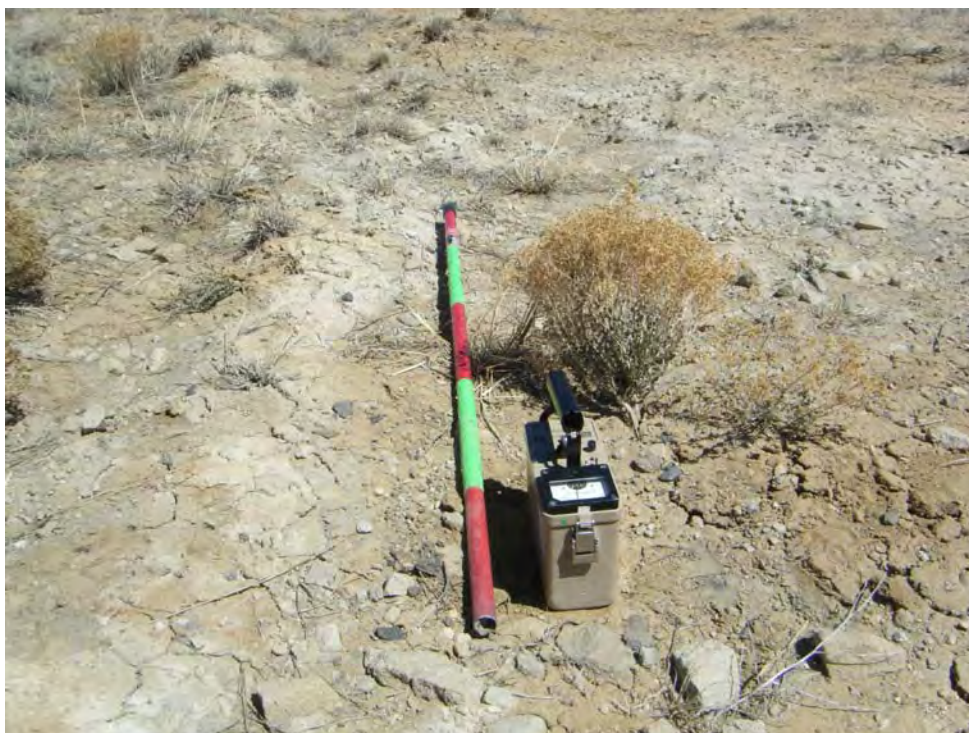
Photo 8-Radiation survey point Rad-6 (350  $\mu$ R/hr at 0 meters).

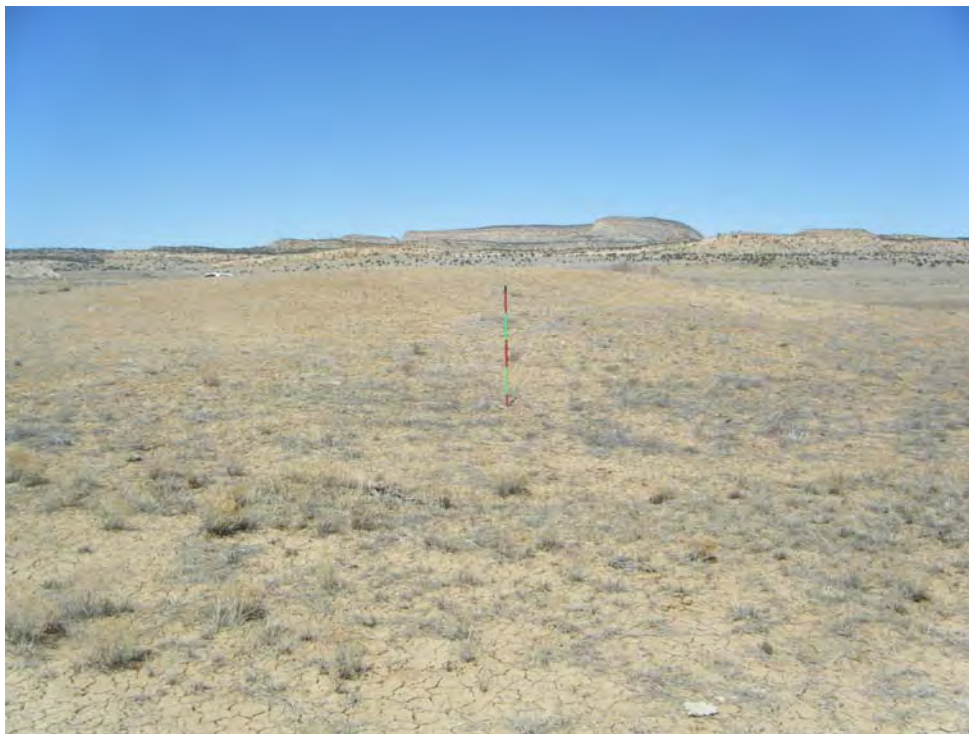
Photo 9-Looking northwest at PilePly-1.

Pile Ply-1 - 10' tall; 120' wide, 120' long; soil

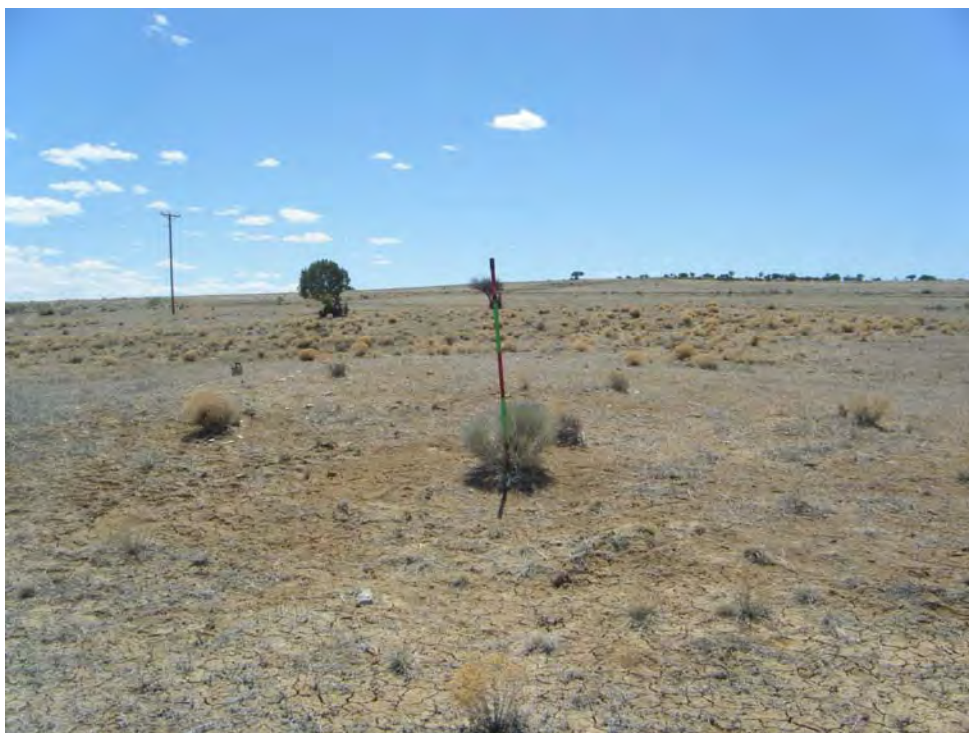
Photo 10-Looking southwest at PilePly-2.

Pile Ply-2 - 4' tall, 120' wide, 270' long; soil

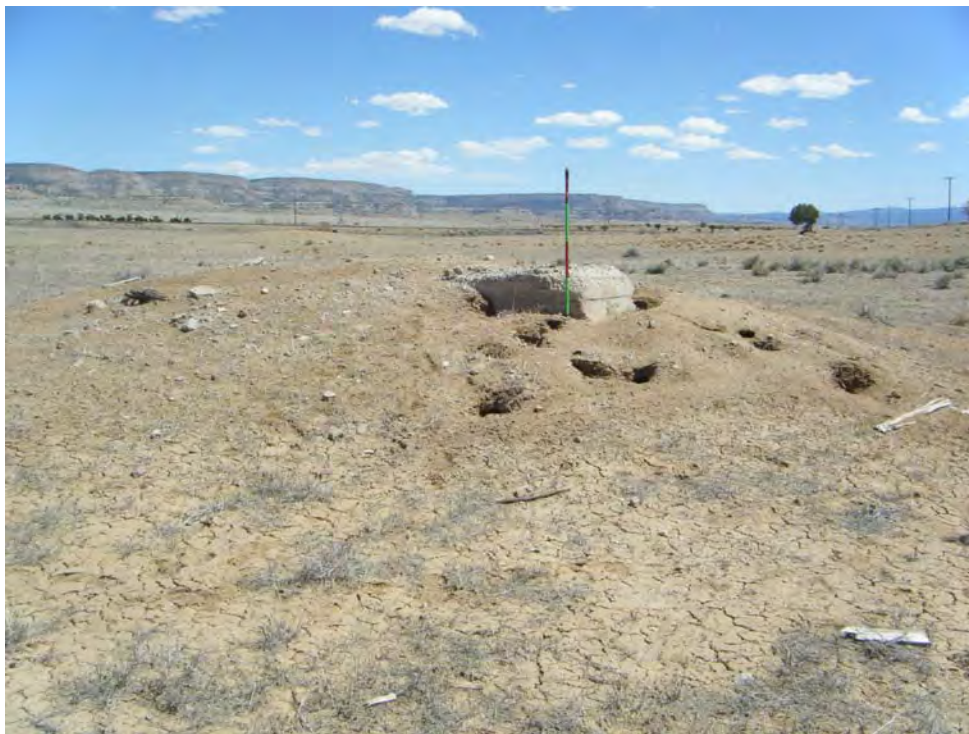
Four piles were found at the AUM Site. These piles consist of (or were later capped by) soil, but some rock with associated uranium minerals can still be found in the piles. One pile (PilePly-3) contained cement blocks (see Photo 11 in Appendix A). The highest gamma radiation reading on these piles was taken at radiation survey point Rad-10 (PilePly-3, 350  $\mu$ R/hr at 0 ft above ground).

Photo 11-Looking east at PilePly-3.

Rad 9 - Pile Ply-2; Om - 110  $\mu$ R/h; 1m - 60  $\mu$ R/hPile Ply-3 - 5' tall, 50' wide, 75' long; soil with cement  
blocks in it

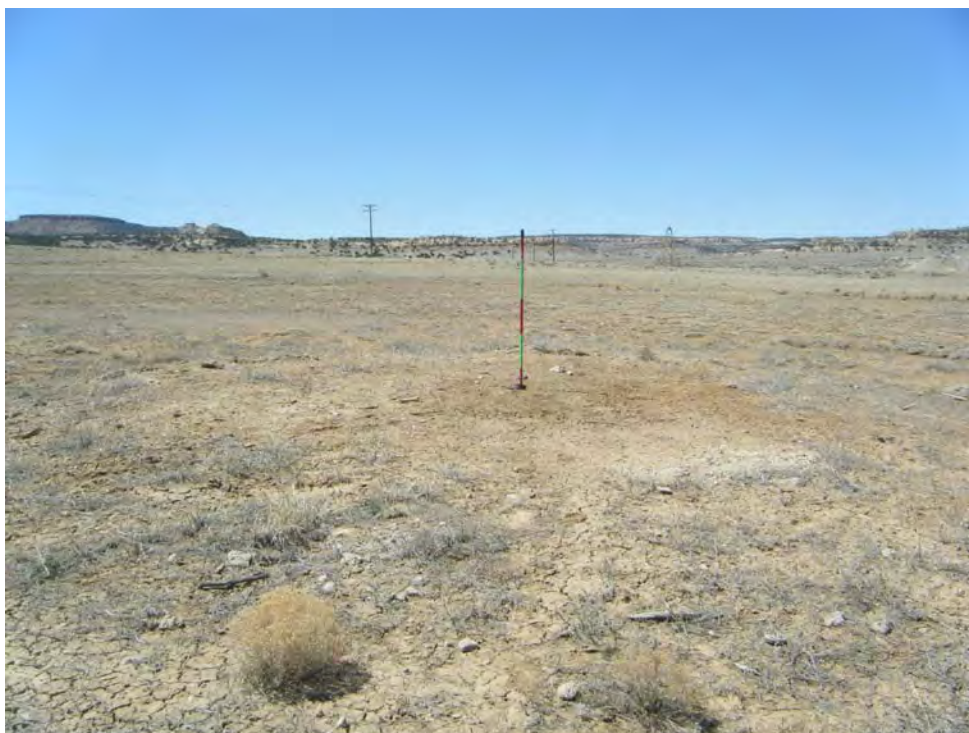
Photo 12-Looking west at PilePly-4.

Rad 10 - Pile Ply-3; Om - 350  $\mu$ R/h; 1m - 60  $\mu$ R/hPile Ply-4 - 2' tall, 20' wide, 30' long; soil with cement and  
various metal in it

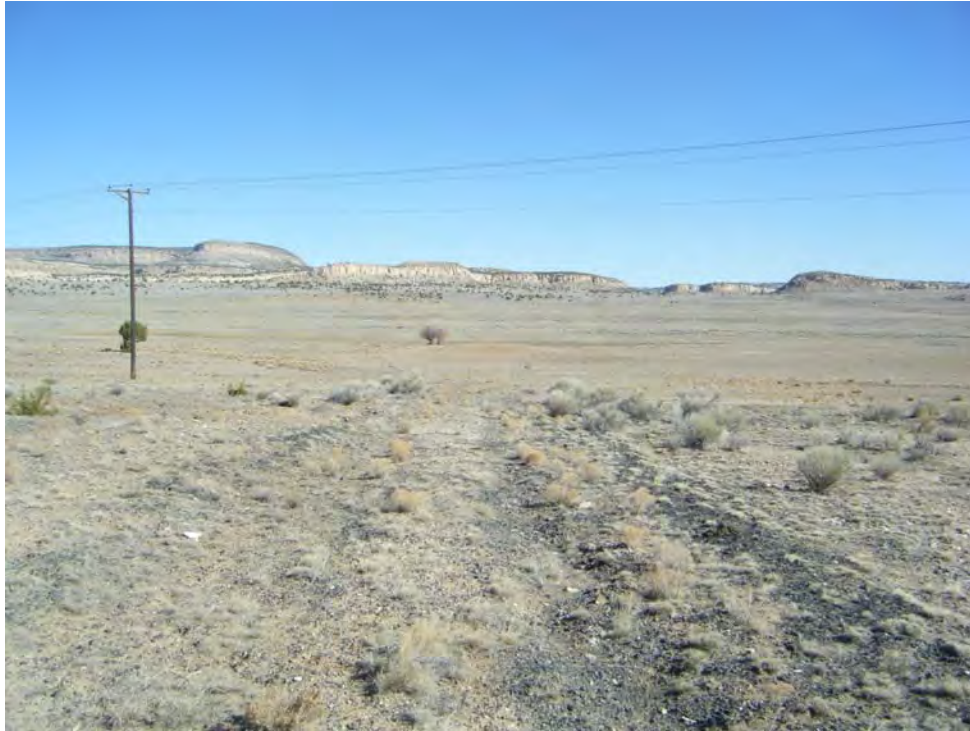
Photo 13-Site photo, looking northwest.

Photo 13 - looking northwest at access to site
